Parkview Recreation Association, Inc.

8 Redwood Avenue, Corte Madera, CA 94925

Senate Bill 326 Report

Report Date: November 22, 2023

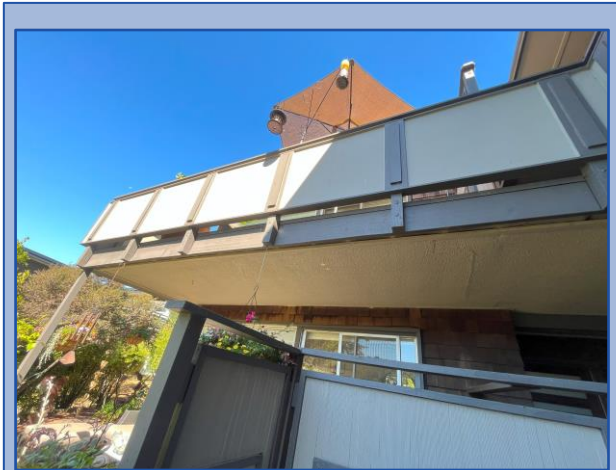
Underside of balcony is in good condition

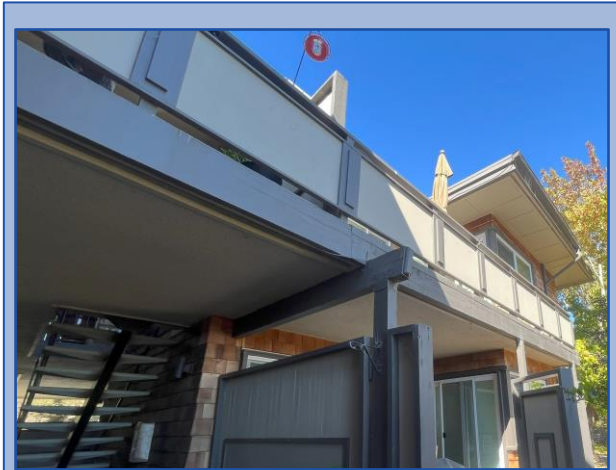
Underside of balcony is in good condition

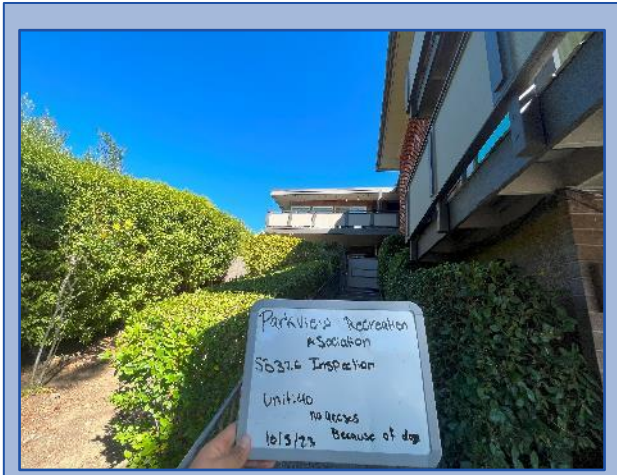
Unit 40 – Closed Soffit Balcony – Limited Access Due to Dog

Overall Balcony

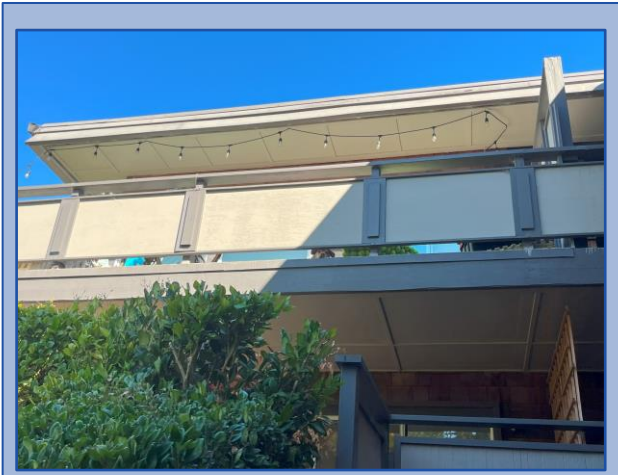
Underside of balcony is in good condition

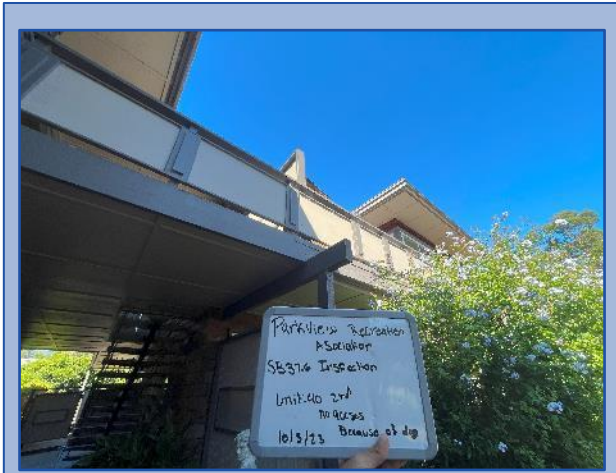
Unit 40 2nd Balcony – Closed Soffit Balcony – Limited Access Due to Dog

Overall Balcony

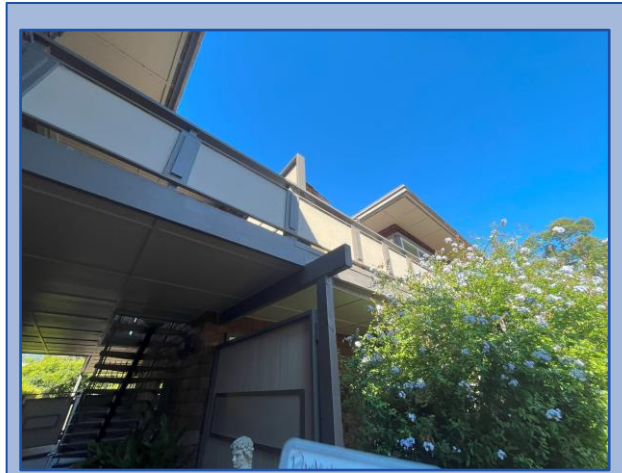
Underside of balcony is in good condition

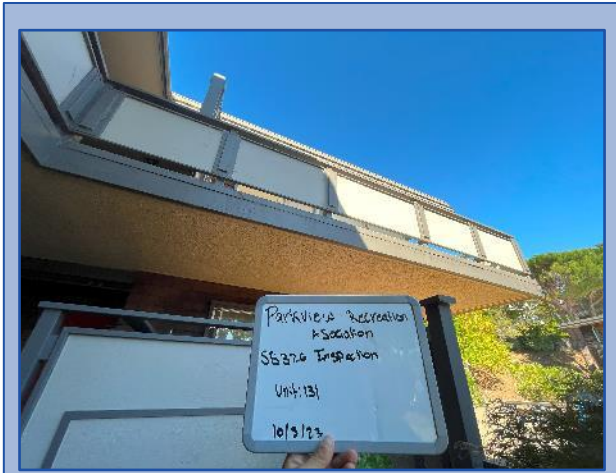
Unit 131 – Closed Soffit Balcony

Overall Balcony

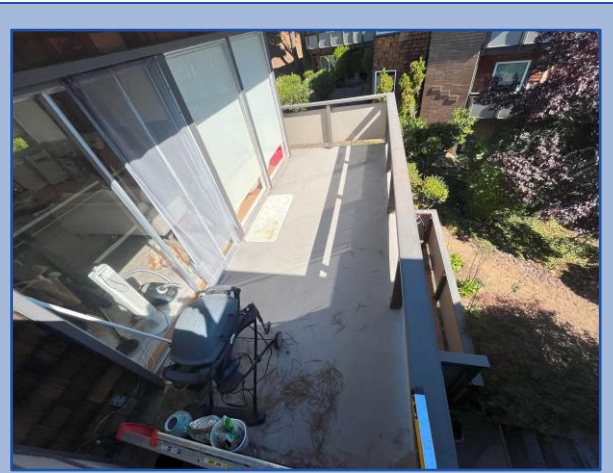
Balcony surface is in good condition

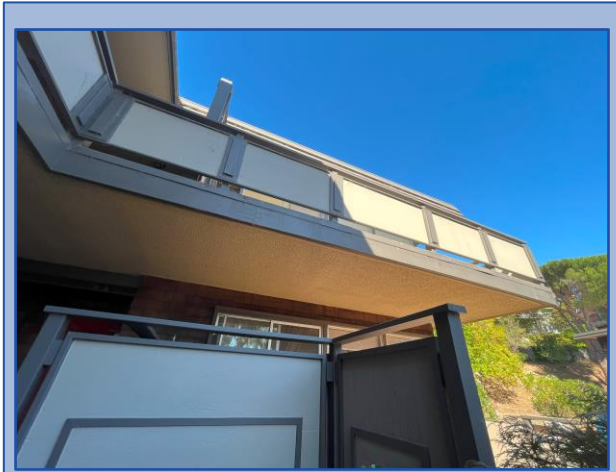
Underside of balcony is in good condition

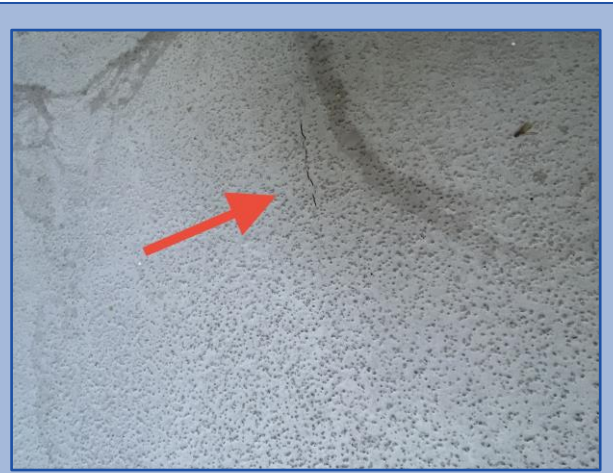
Balcony surface contains small crack; repairs are recommended

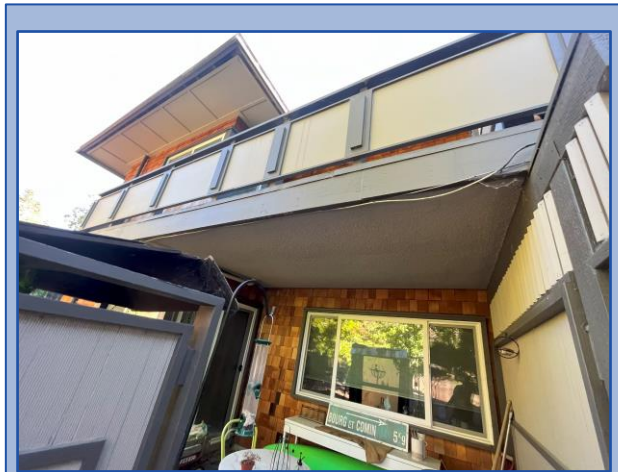
Underside of balcony is in good condition

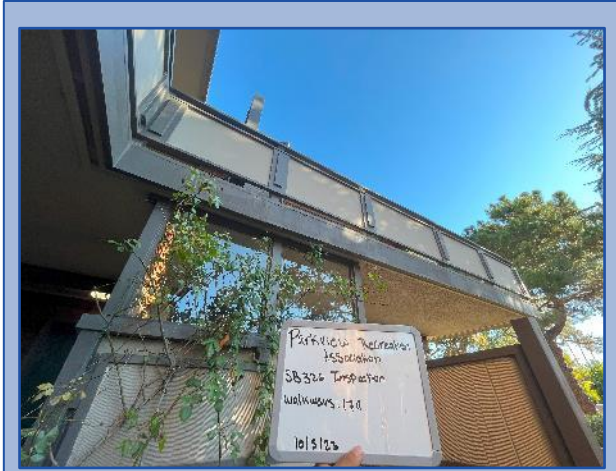
Unit 179 – Closed Soffit Balcony

Overall Balcony

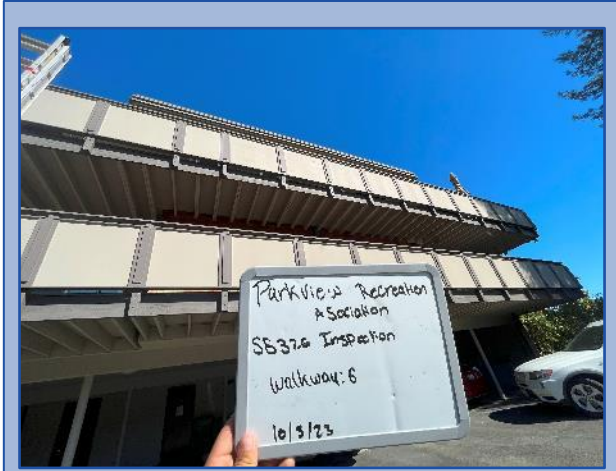
Unit 6 Walkway – Open Soffit

Overall Walkway

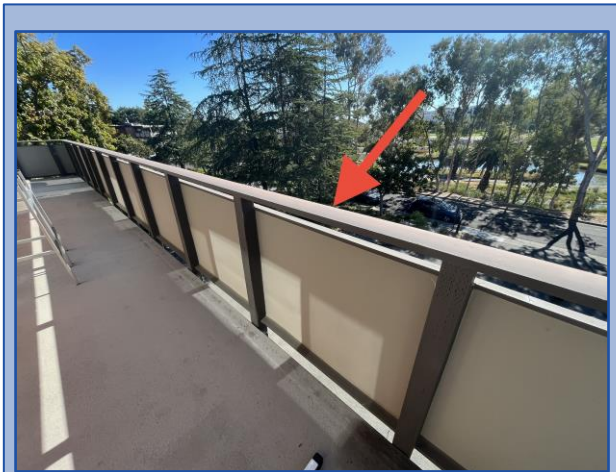
Railing is loose; repairs are recommended

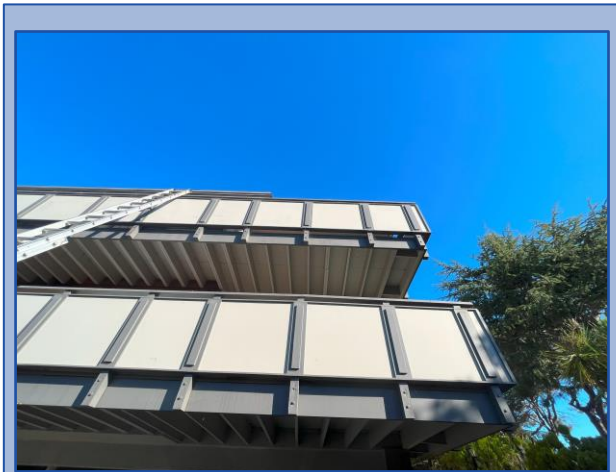
Railing is loose; repairs are recommended
