Parkview Recreation Association, Inc.

8 Redwood Avenue, Corte Madera, CA 94925

Senate Bill 326 Report

Report Date: November 22, 2023

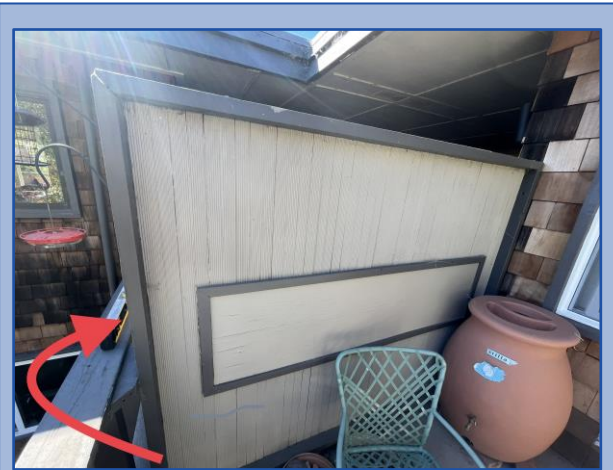
Some inspected railings at the balconies and elevated walkways were observed to be loose. Refastening loose railing attachments at the affected units is recommended at this time to ensure the safety of the railings. Additionally, the separation wall at the surface of some inspected closed soffit balconies were observed to be loose or have rotted components. While this does not affect the structural integrity of these units, repairs are recommended for these walls at this time.

Loose and decayed separation wall; repairs are recommended

Unit	Action Required	Element Description
Unit 8 2nd Balcony – Closed Soffit	2	Repair/Replace separation wall
Unit 167 2 nd Balcony – Closed Soffit	1,2	Repair/Resurface coated surface(s), Repair/Replace separation wall
Unit 179 2 nd Balcony – Closed Soffit	2	Repair/Replace separation wall
Unit 107 – Open Soffit Balcony	3	Repair/Replace railing
Unit 113 – Open Soffit Balcony	3	Repair/Replace railing
Unit 117 – Open Soffit Balcony	3	Repair/Replace railing
Walkway 2 – Open Soffit Walkway	3	Repair/Replace railing
Walkway 6 – Open Soffit Walkway	1,3	Repair/Resurface coated surface(s), Repair/Replace railing
Walkway 34 – Open Soffit Walkway	3	Repair/Replace railing
Walkway 38 – Open Soffit Walkway	3	Repair/Replace railing
Walkway 125 – Open Soffit Walkway	3	Repair/Replace railing
Walkway 141 – Open Soffit Walkway	3	Repair/Replace railing
Walkway 149 – Open Soffit Walkway	3	Repair/Replace railing
Walkway 153 – Open Soffit Walkway	3	Repair/Replace railing

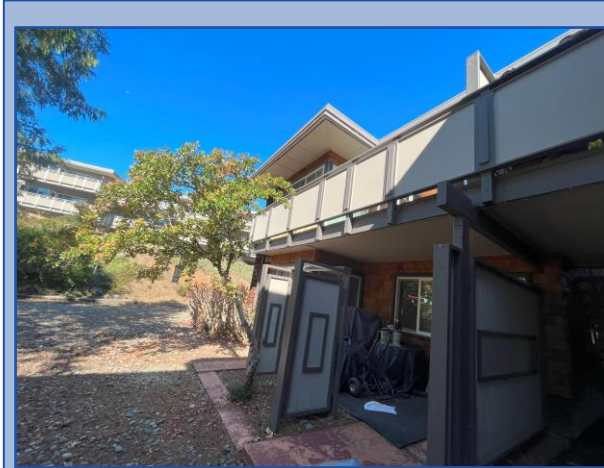
Underside of balcony is in good condition

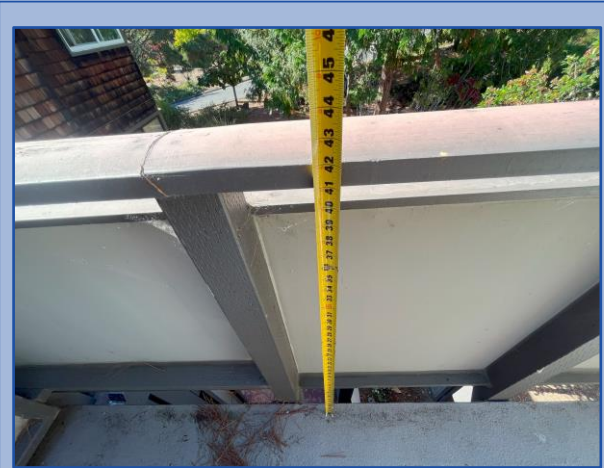
Railing height meets current building code requirements

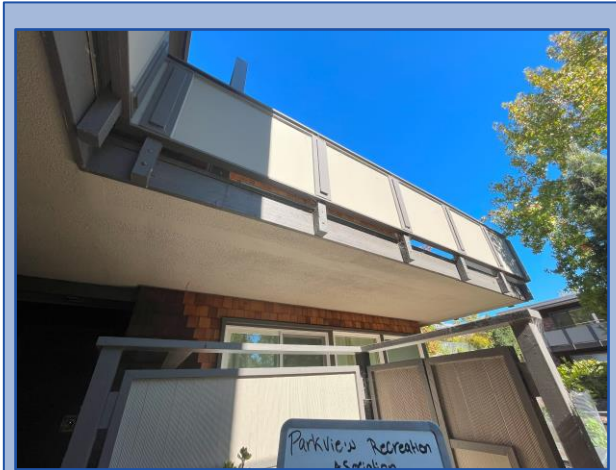
Underside of balcony is in good condition

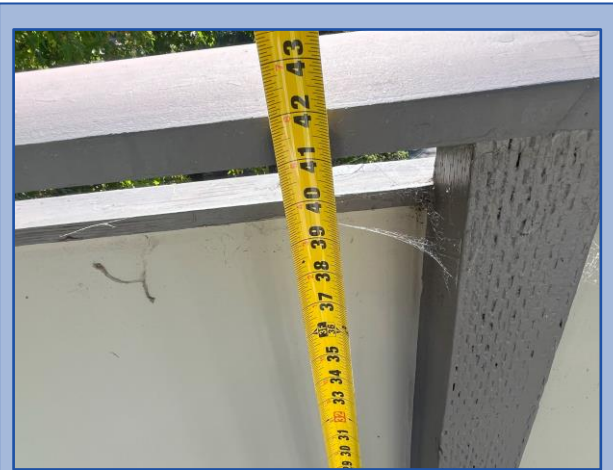
Railing height meets current building code requirements

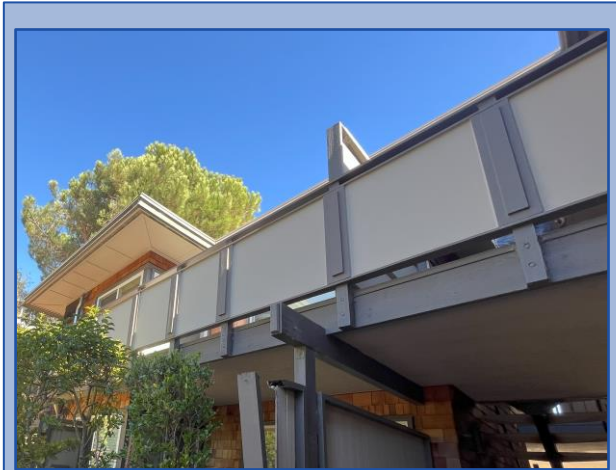
Underside of balcony is in good condition

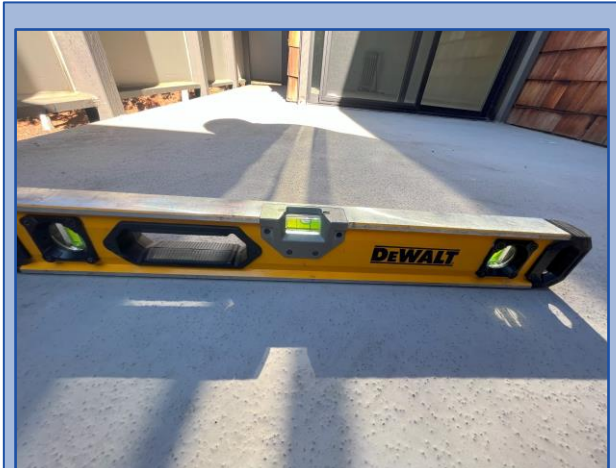
Balcony surface is properly sloped to encourage drainage

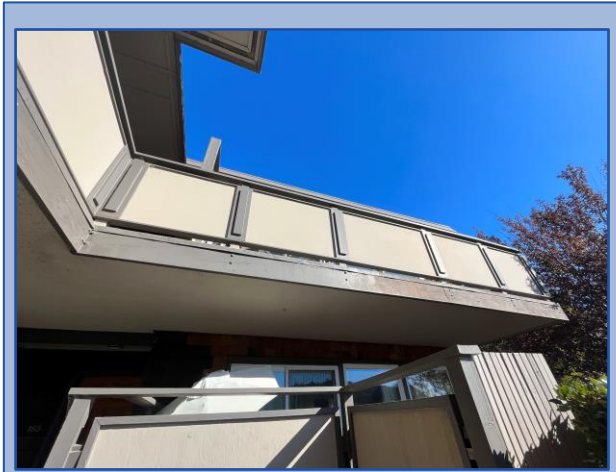
Underside of balcony is in good condition

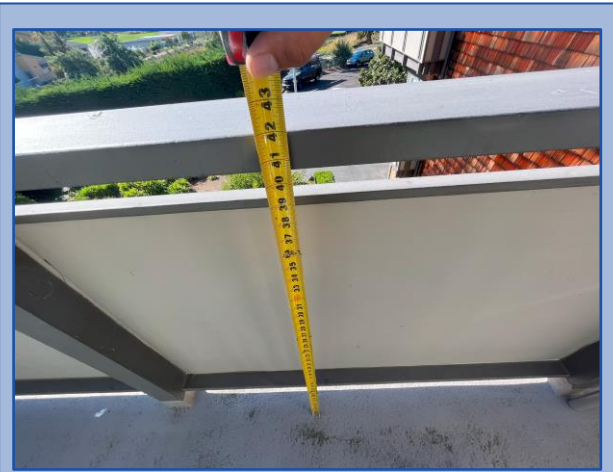
Railing height meets current building code requirements

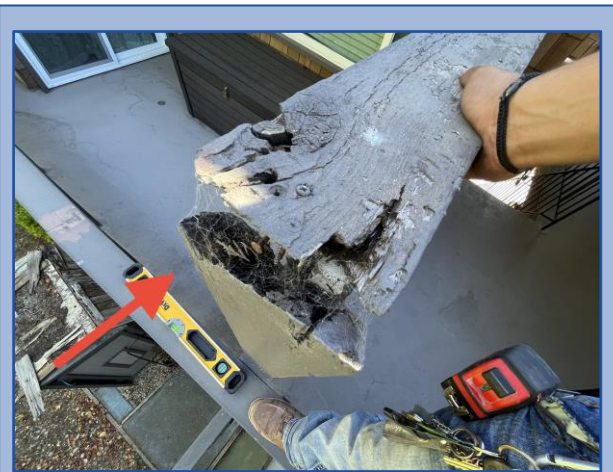
Rotted and loose separation wall; repairs are recommended

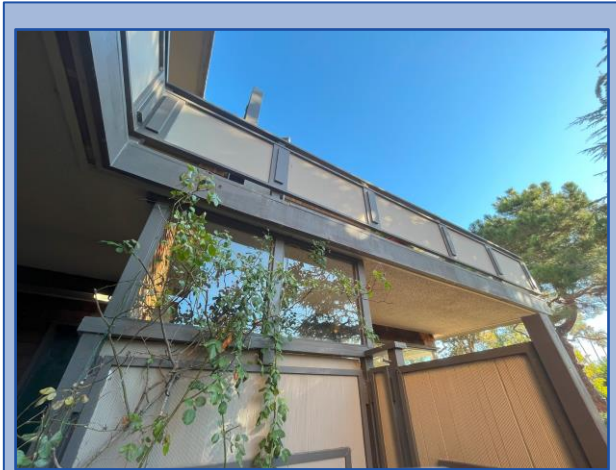
Underside of balcony is in good condition

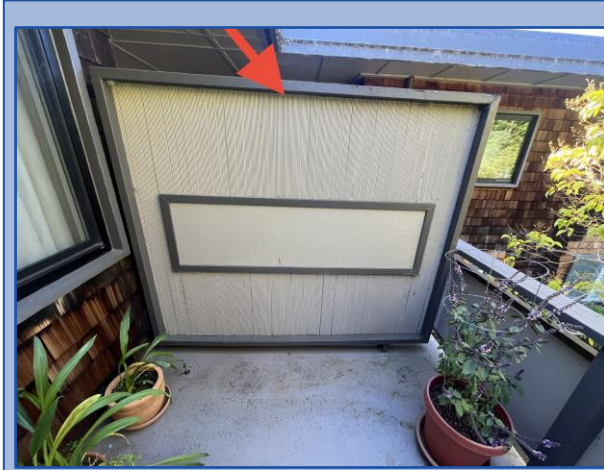
Separation wall is loose; repairs are recommended

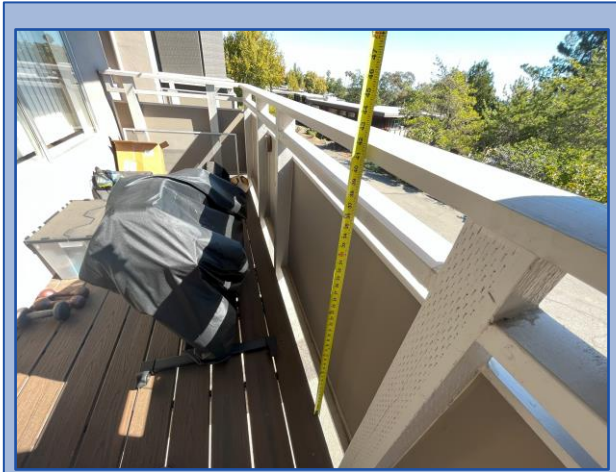
Railing height meets current building code requirements

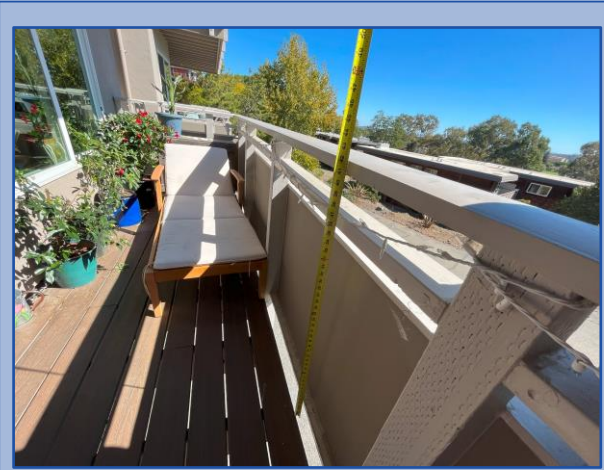
Railing height meets current building code requirements

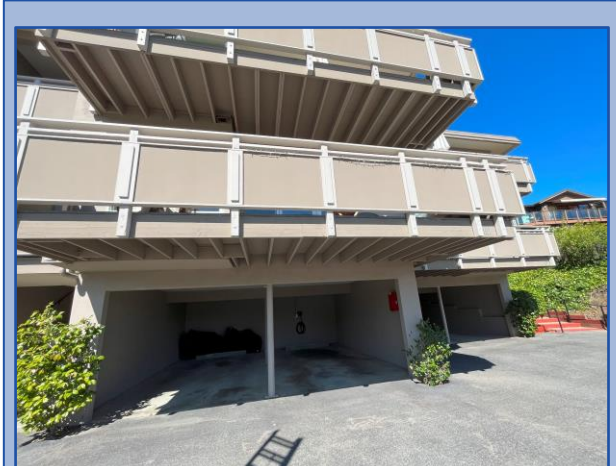
Underside of balcony and framing are in good condition

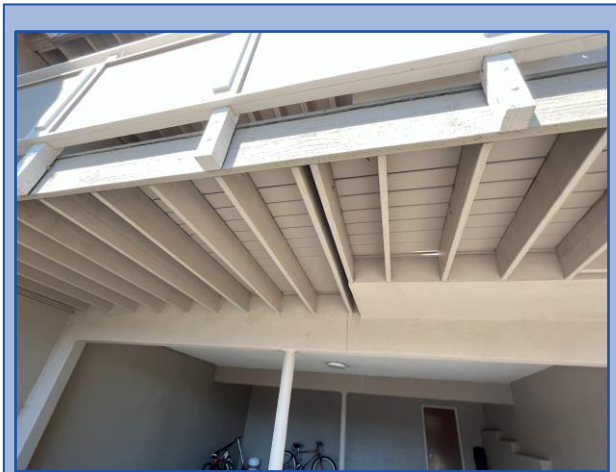
Underside of balcony and framing are in good condition

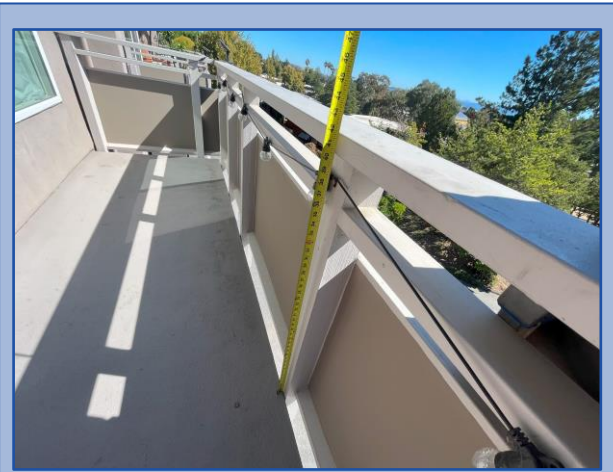
Railing height meets current building code requirements

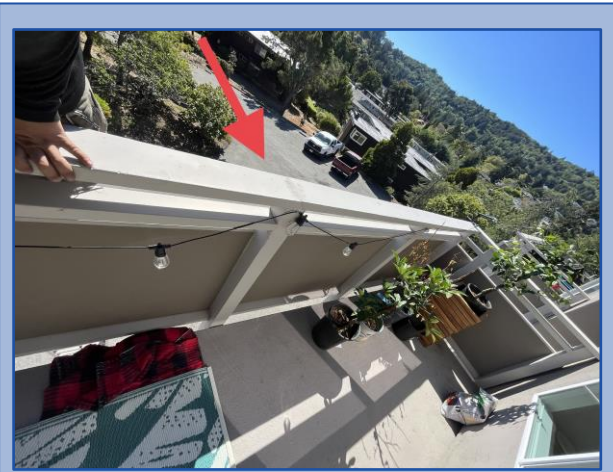
Railing is loose; repairs are recommended

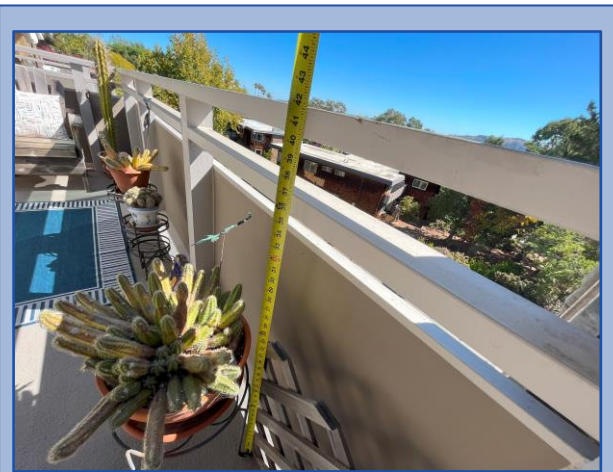
Railing height meets current building code requirements

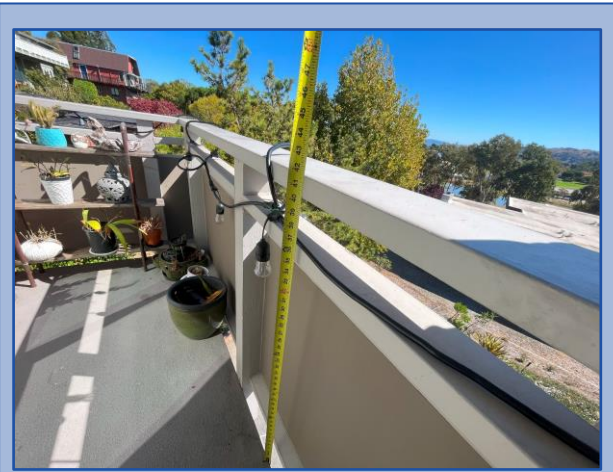
Railing height meets current building code requirements

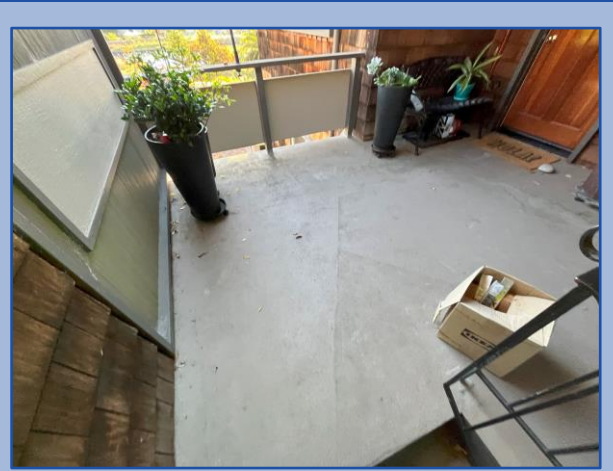
Walkway surface is in good condition

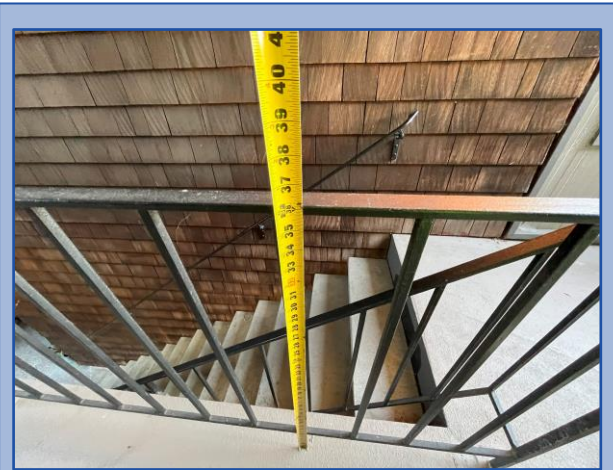
Railing height and baluster spacing do not meet current building code requirements

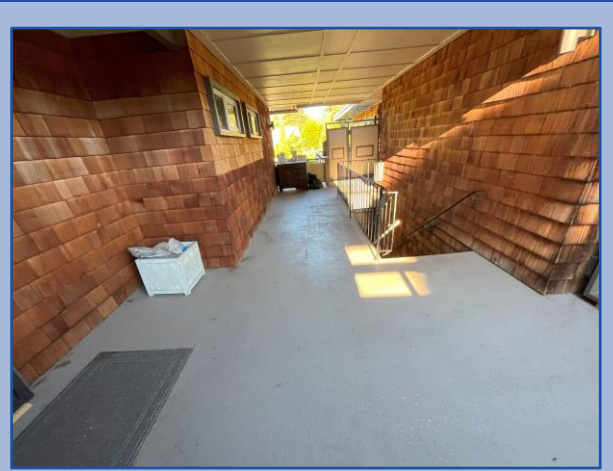
Walkway surface is in good condition

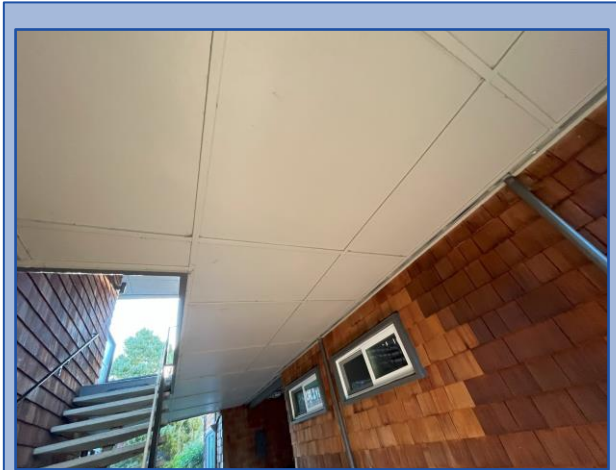
Underside of walkway is in good condition

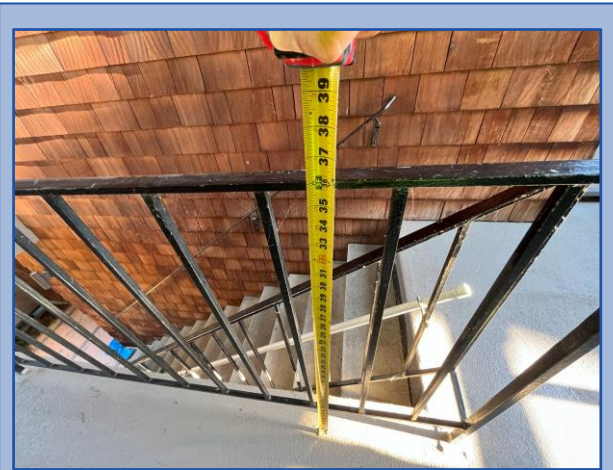
Railing height and baluster spacing do not meet current building code requirements

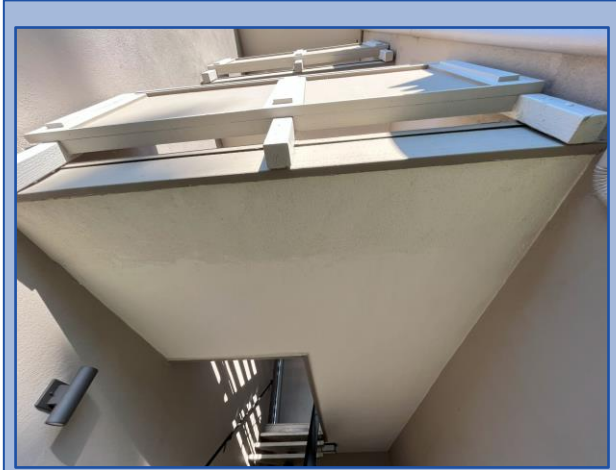
Underside of walkway is in good condition

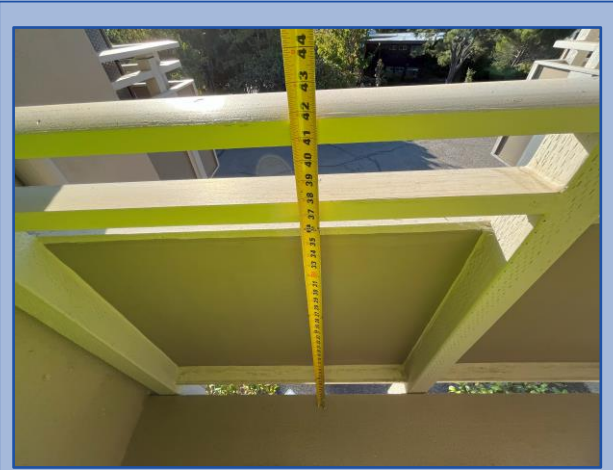
Railing height and baluster spacing meet current building code requirements

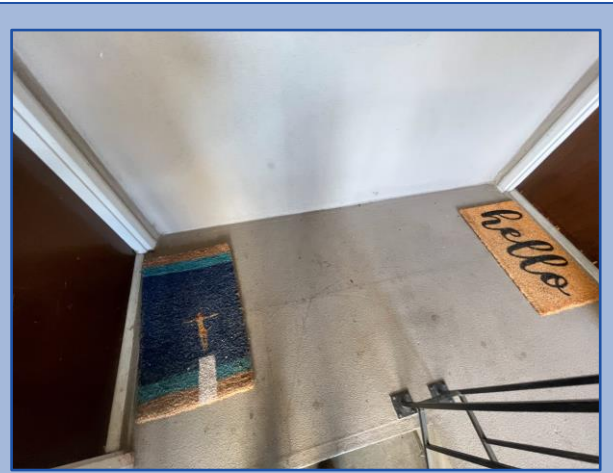
Walkway surface is in good condition

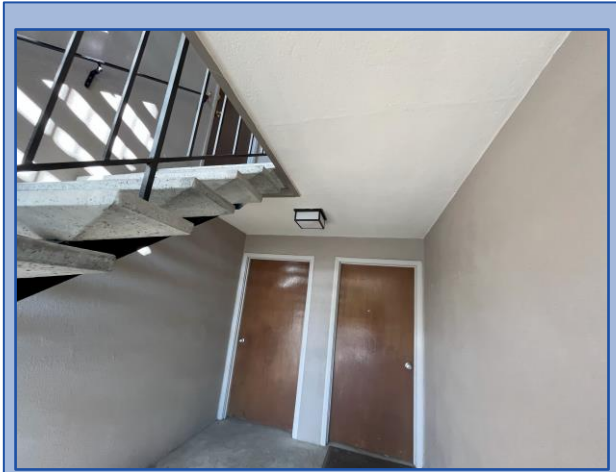
Underside of walkway is in good condition

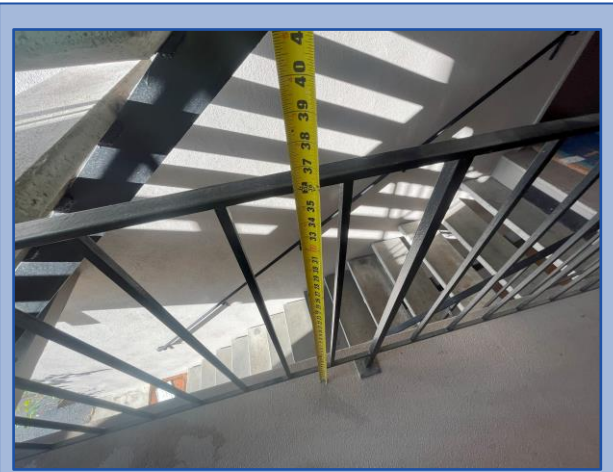
Railing height and baluster spacing do not meet current building code requirements

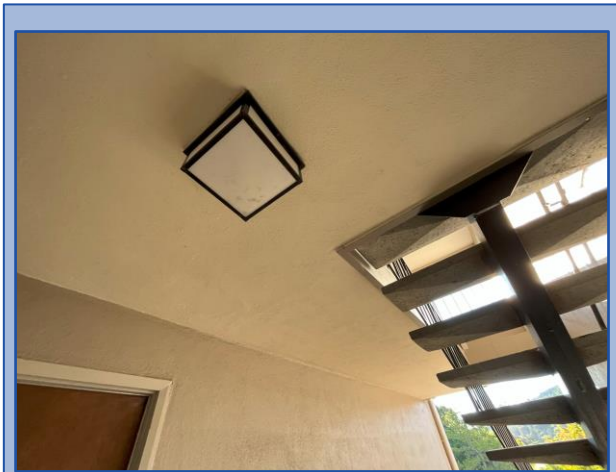
Underside of walkway is in good condition

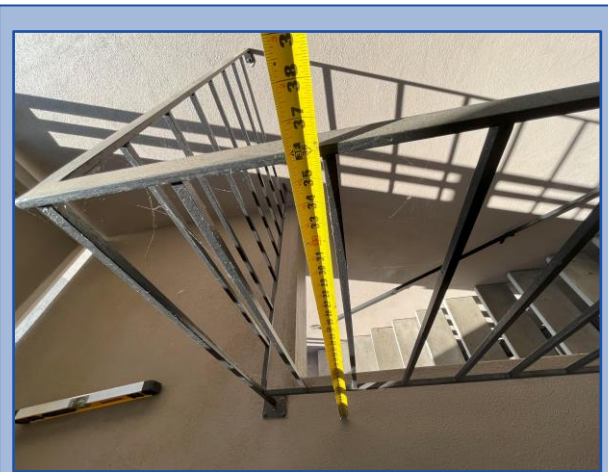
Railing height and baluster spacing do not meet current building code requirements

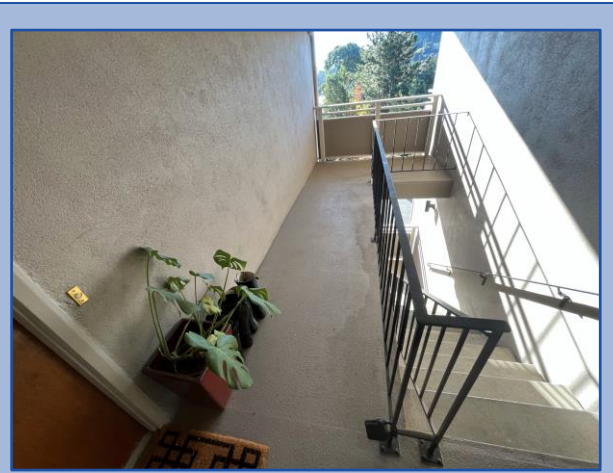
Walkway surface is in good condition

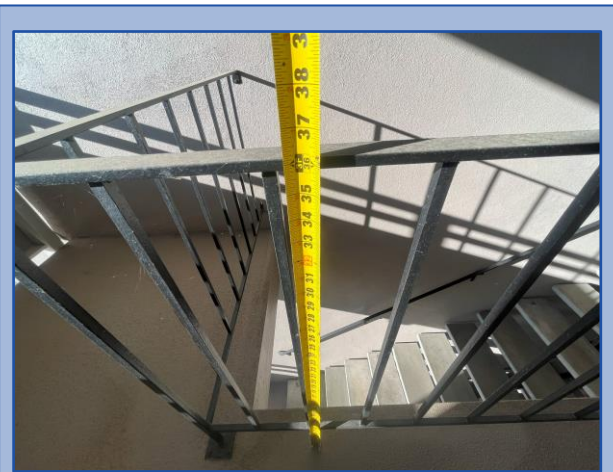
Railing height and baluster spacing do not meet current building code requirements

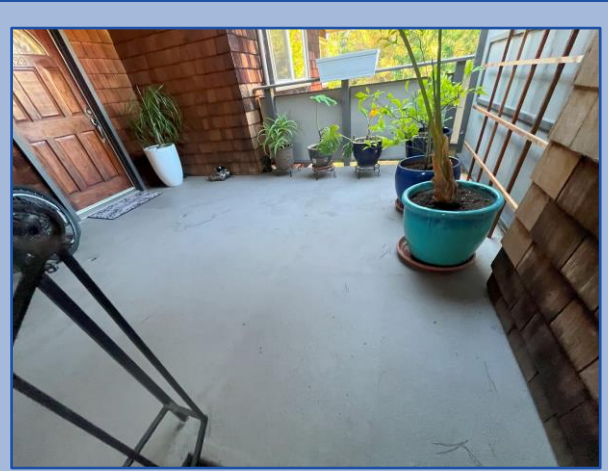
Walkway surface is in good condition

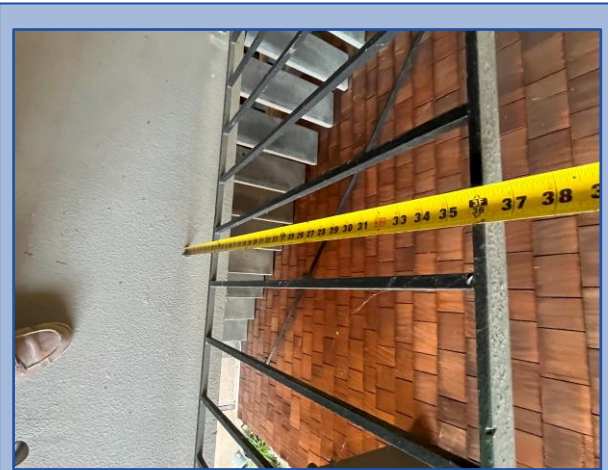
Railing height and baluster spacing do not meet current building code requirements

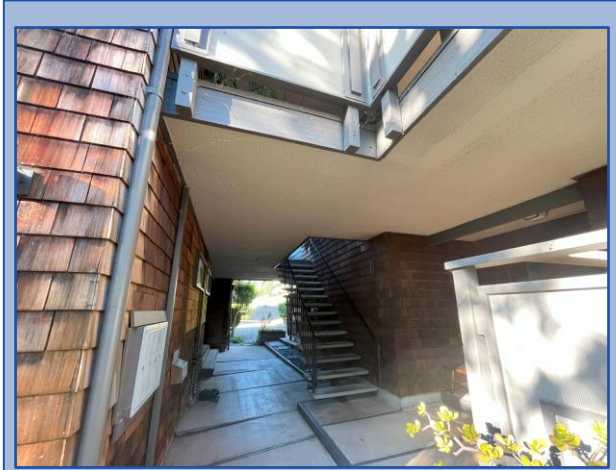
Underside of walkway is in good condition

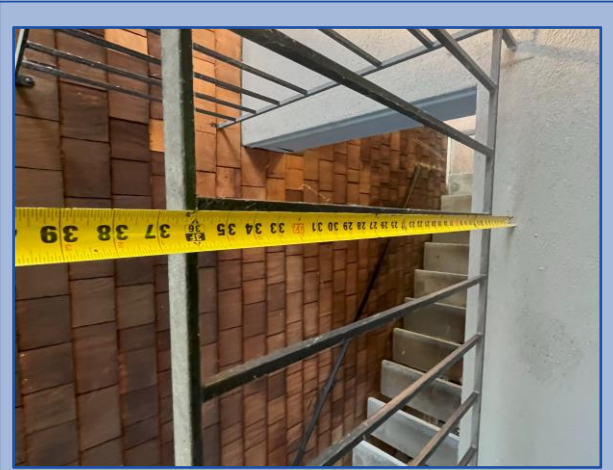
Railing height and baluster spacing do not meet current building code requirements

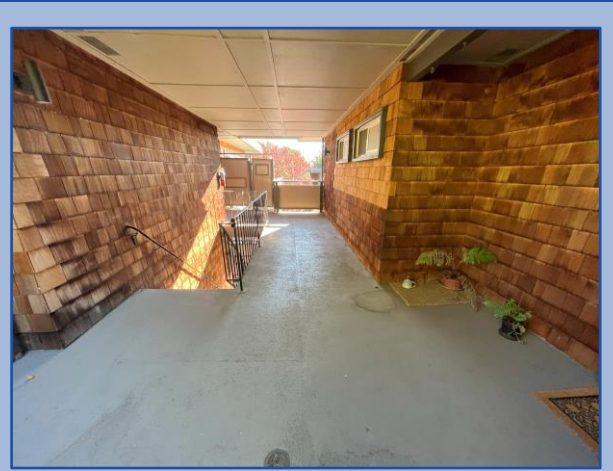
Walkway surface is in good condition

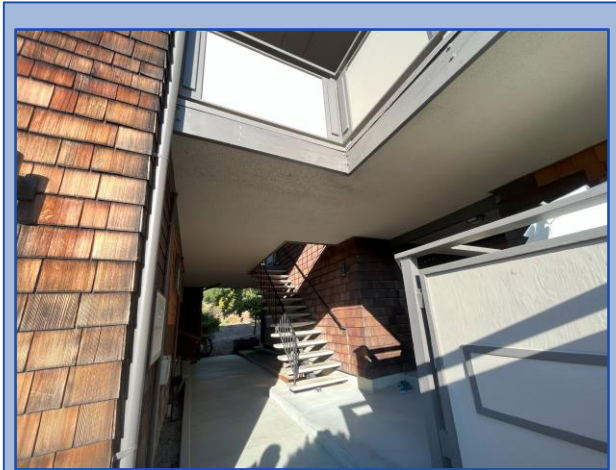
Underside of walkway is in good condition

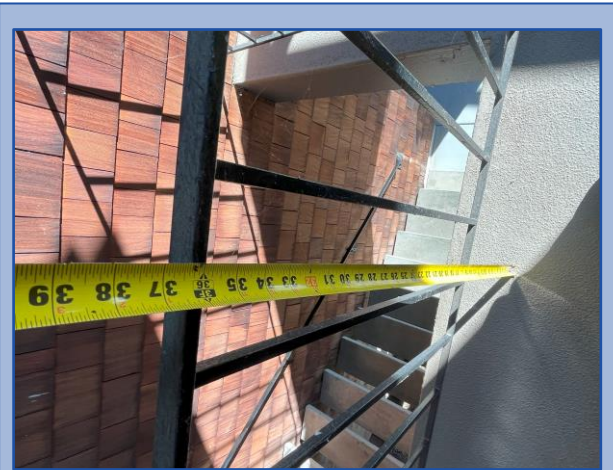
Railing height and baluster spacing do not meet current building code requirements

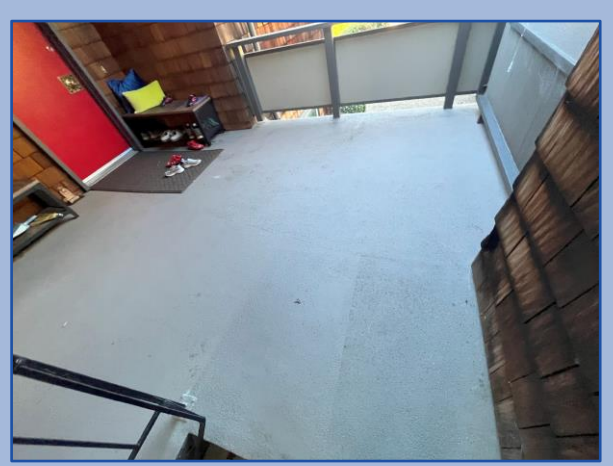
Walkway surface is in good condition

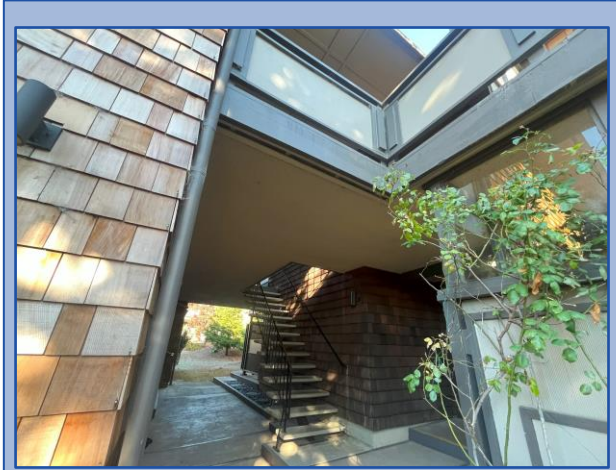
Underside of walkway is in good condition

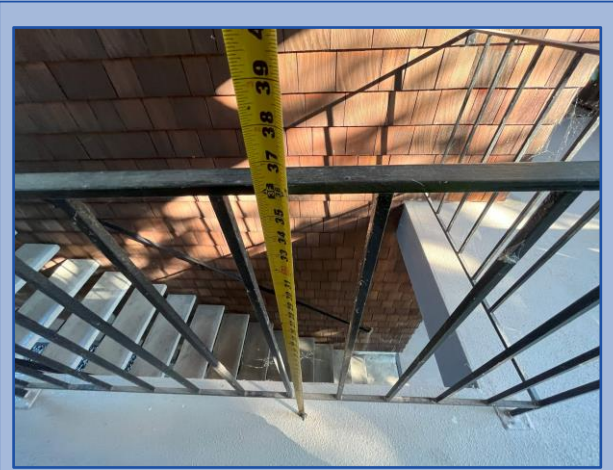
Railing height and baluster spacing do not meet current building code requirements

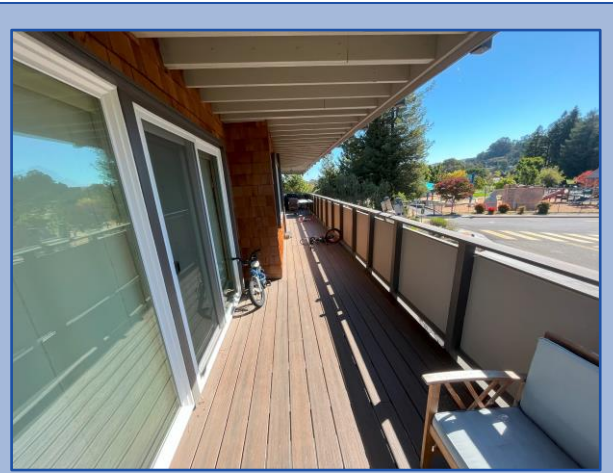
Walkway surface is in good condition

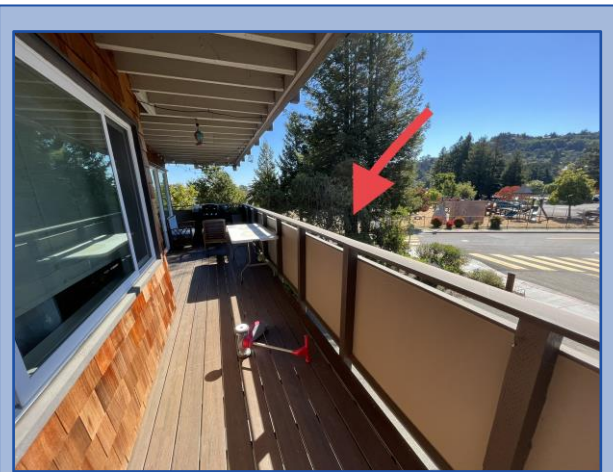
Railing is loose; repairs are recommended

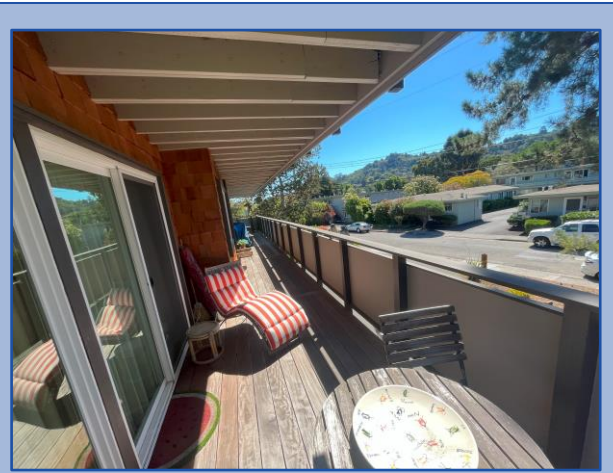
Walkway surface is in good condition

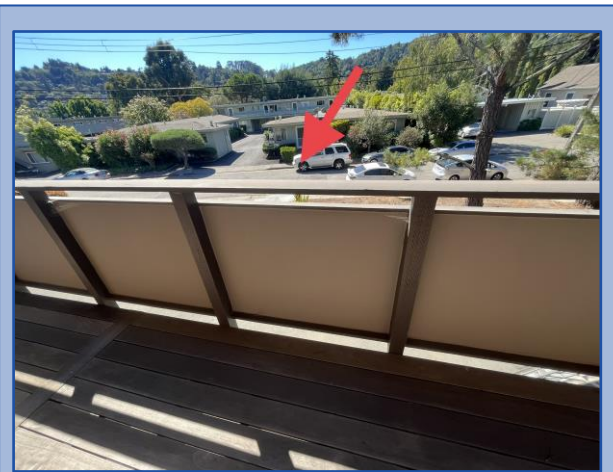
Railing is loose; repairs are recommended

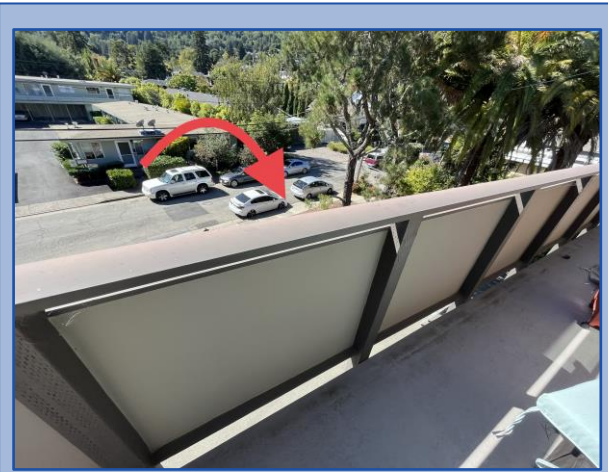
Railing is loose; repairs are recommended

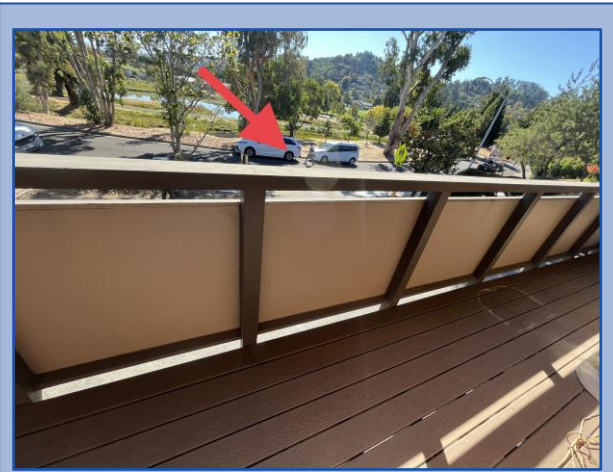
Railing is loose; repairs are recommended

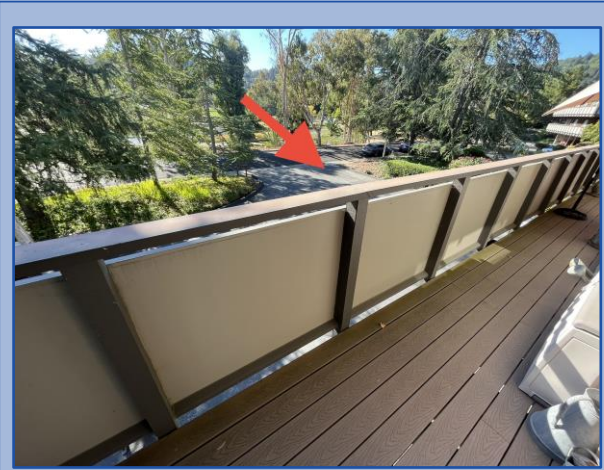
Railing is loose; repairs are recommended

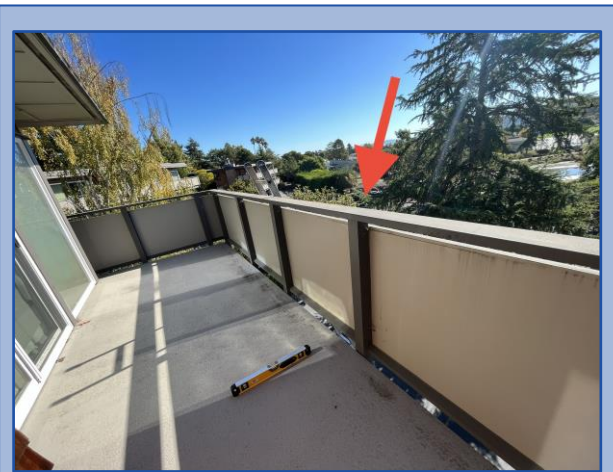
Railing is loose; repairs are recommended

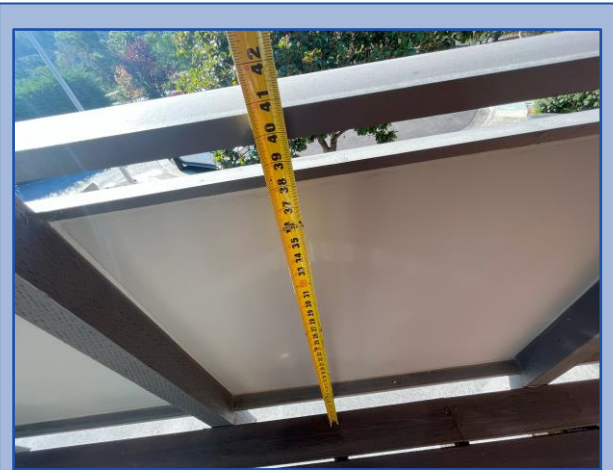
Railing height does not meet current building code requirements

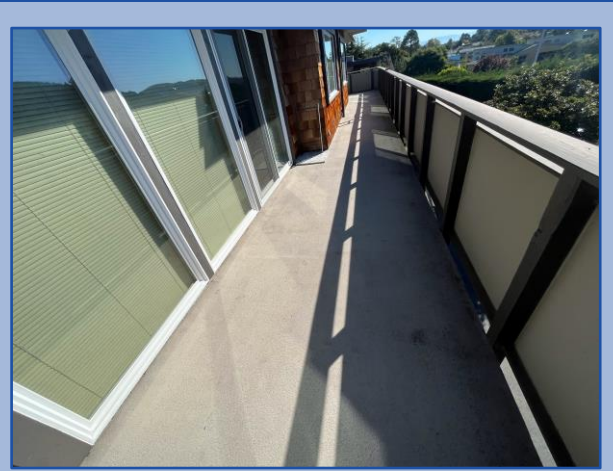
Walkway surface is in good condition

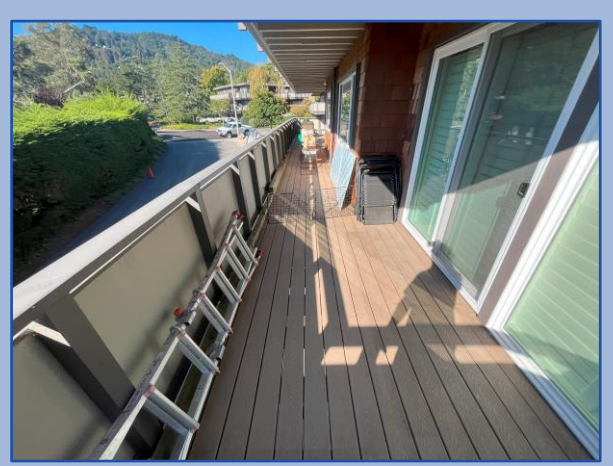
Walkway surface is in good condition

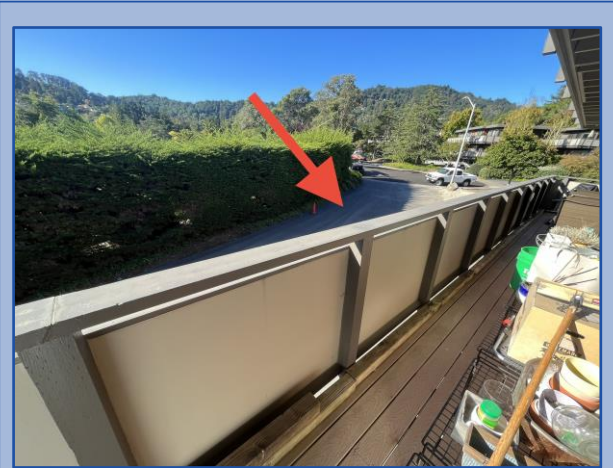
Railing is loose; repairs are recommended

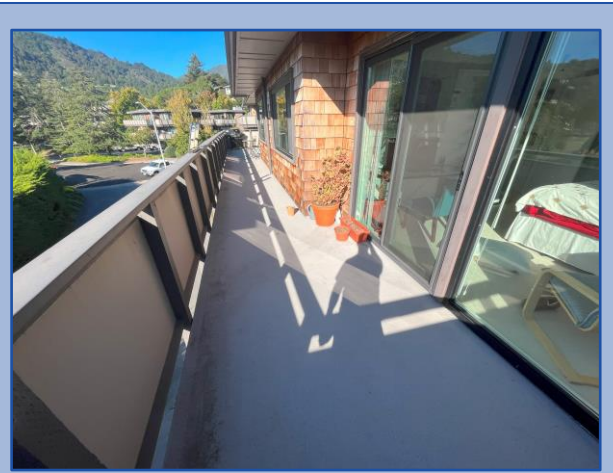
Walkway surface is in good condition

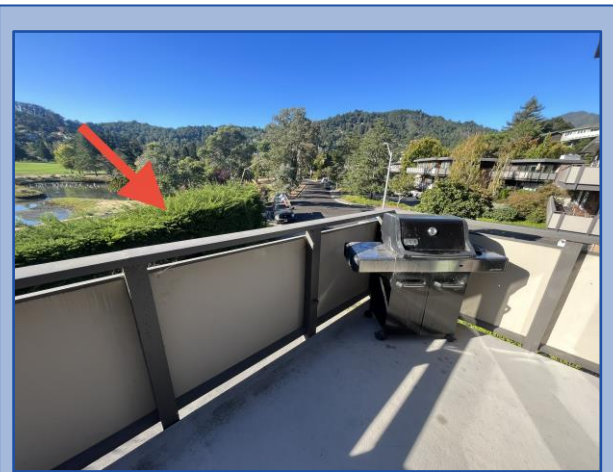
Railing is loose; repairs are recommended
