Parkview Recreation Association, Inc.

8 Redwood Avenue, Corte Madera, CA 94925

Senate Bill 326 Report

Report Date: November 22, 2023

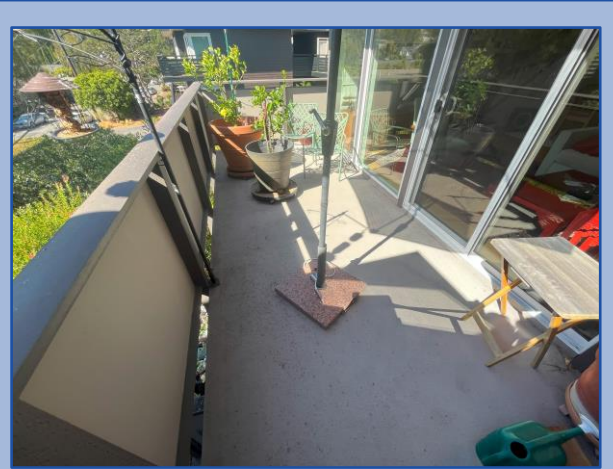
Balcony surface is in good condition

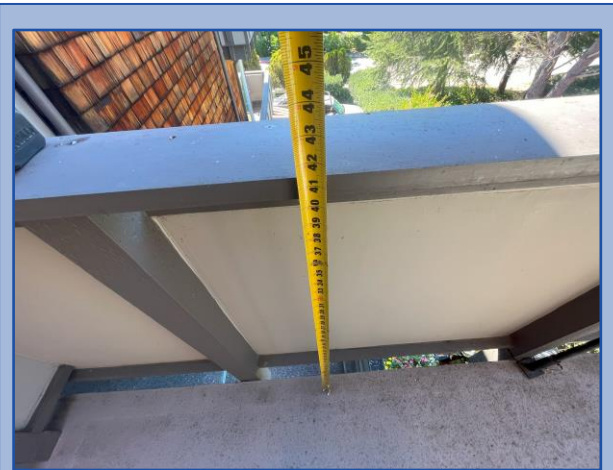
It should be noted that some inspected railings did not meet current building code requirements for height and/or spacing. This is considered legal, non-conforming and no further action is required for this at this time. Railings should measure 42" in height or greater, and any spacing in the railing should be 4" or less.

Railing height does not meet current building code requirements

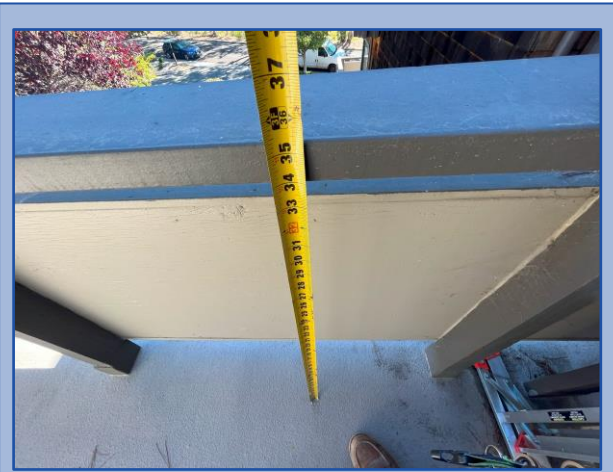
Railing height does not meet current building code requirements

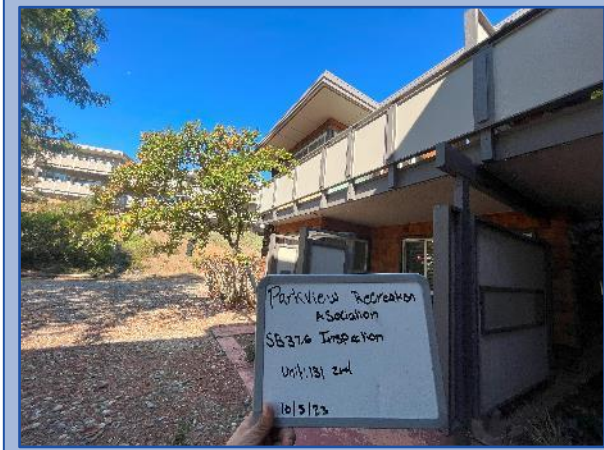
Unit 131 2nd Balcony – Closed Soffit Balcony

Overall Balcony

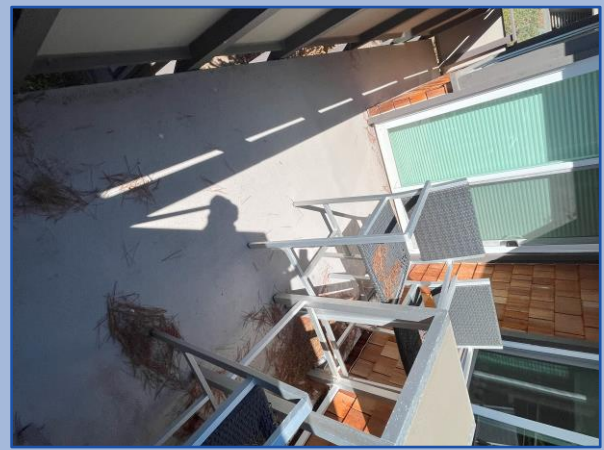
Balcony surface is in good condition

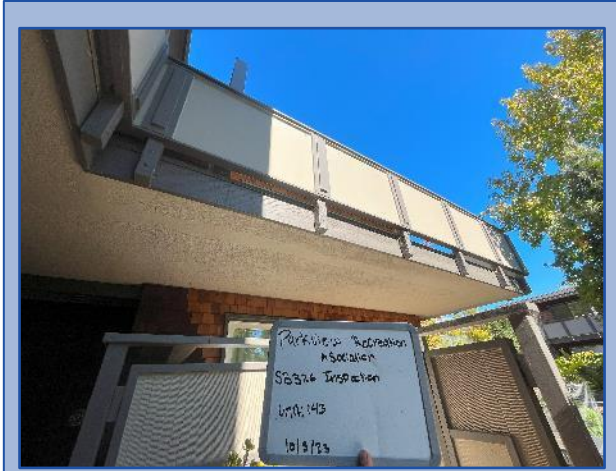
Unit 143 – Closed Soffit Balcony

Overall Balcony

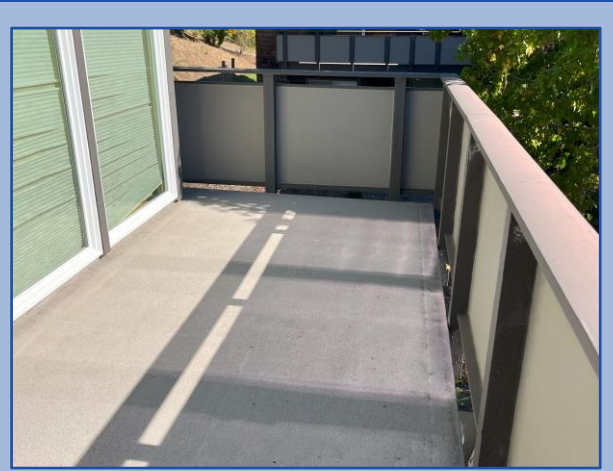
Balcony surface is in good condition

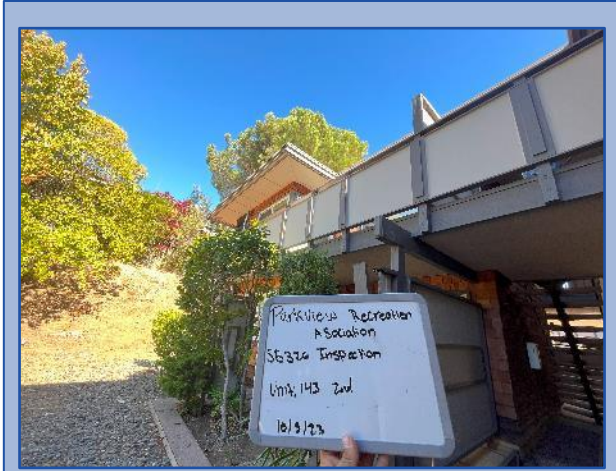
Unit 143 2nd Balcony – Closed Soffit Balcony

Overall Balcony

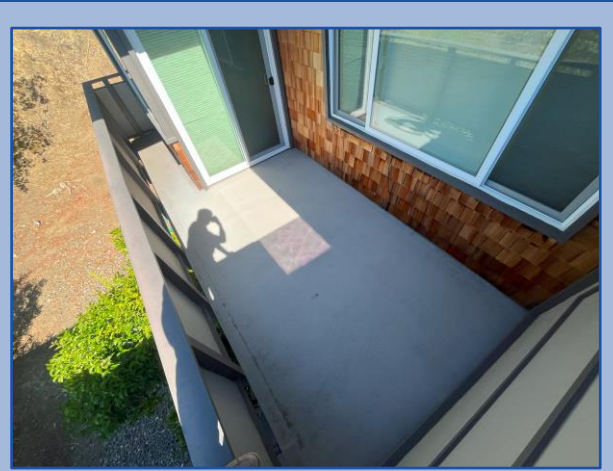
Balcony surface is in good condition

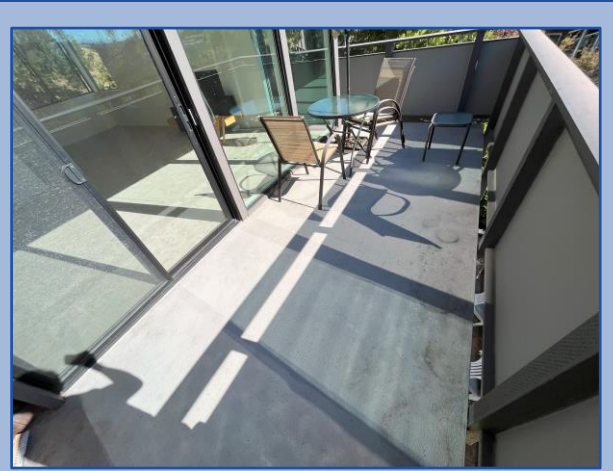
Balcony surface is in good condition

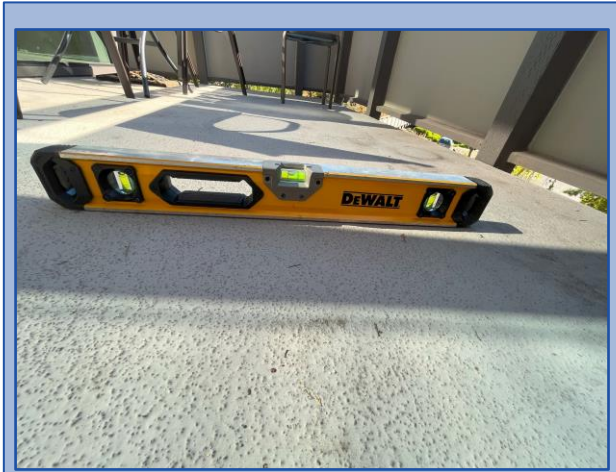
Balcony surface is properly sloped to encourage drainage

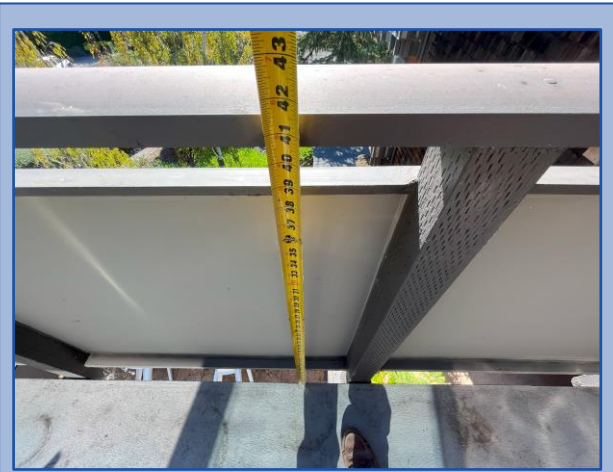
Railing height does not meet current building code requirements

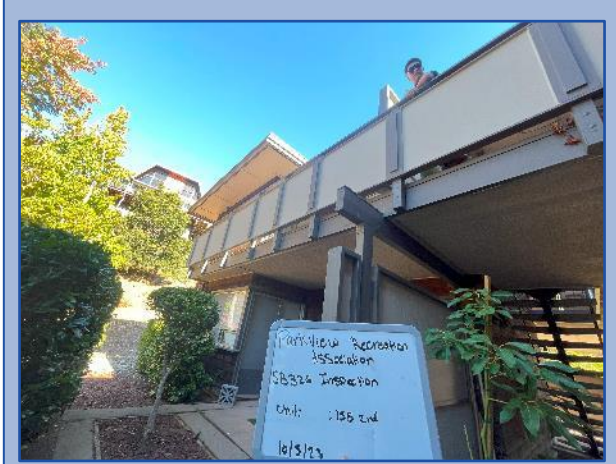
Unit 151 2nd Balcony – Closed Soffit Balcony

Overall Balcony

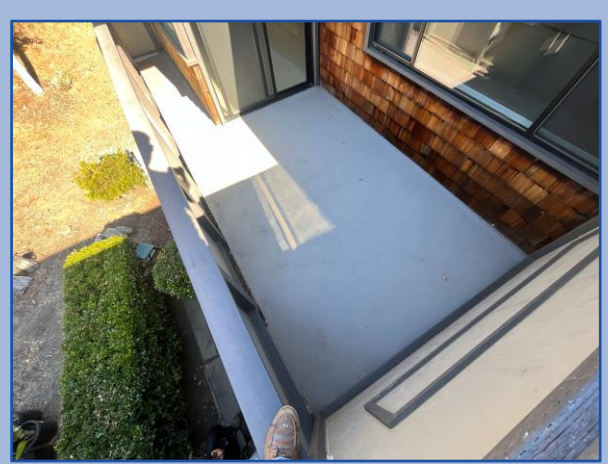
Balcony surface is in good condition

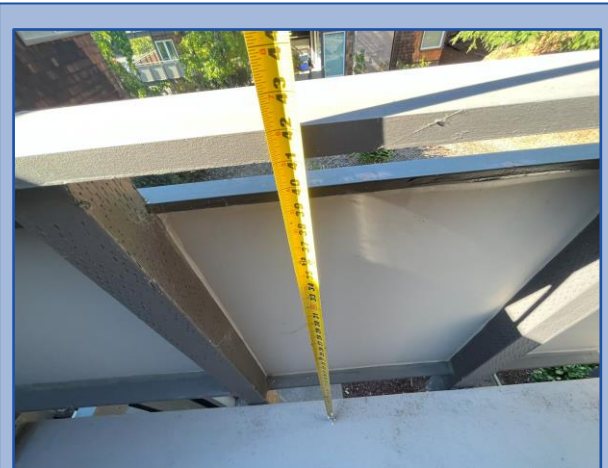
Railing height does not meet current building code requirements

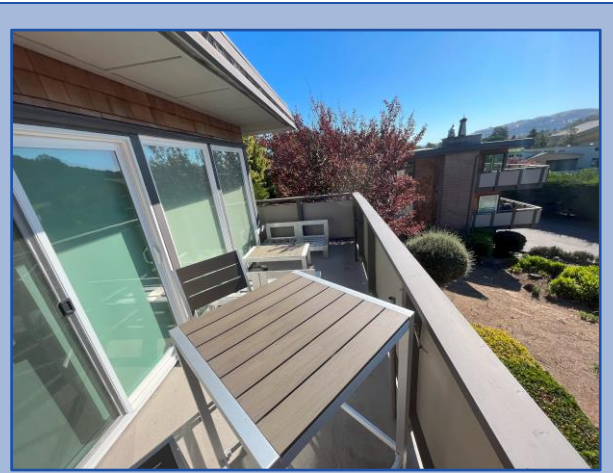
Balcony surface is in good condition

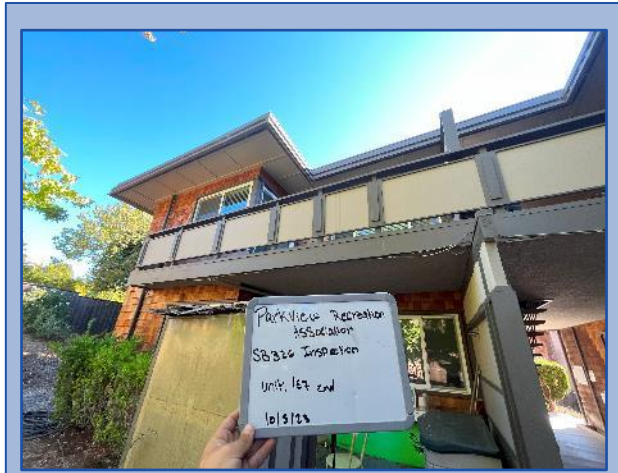
Unit 167 2nd Balcony – Closed Soffit Balcony

Overall Balcony

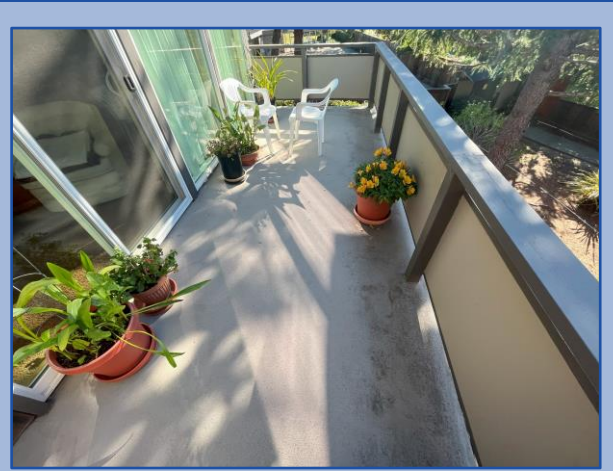
Balcony surface is in good condition

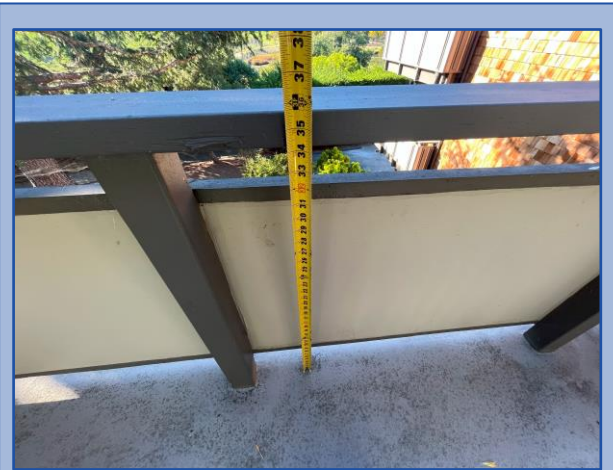
Railing height does not meet current building code requirements

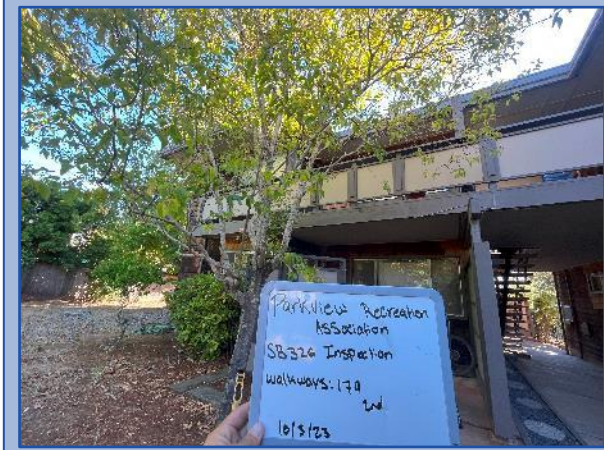
Unit 179 2nd Balcony – Closed Soffit Balcony

Overall Balcony

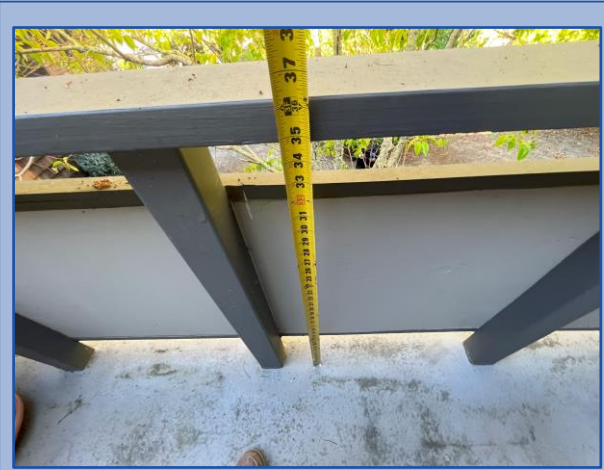
Railing height does not meet current building code requirements

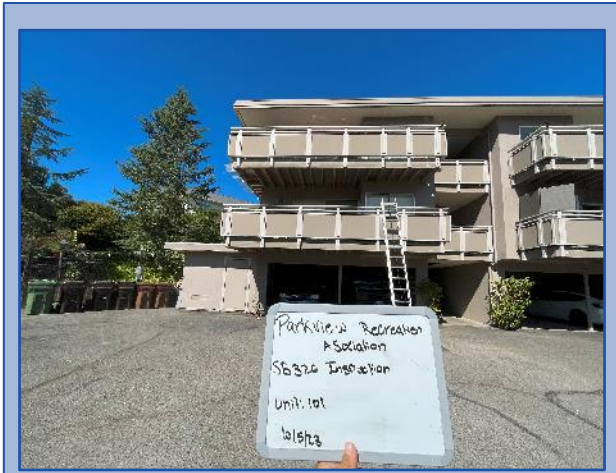
Unit 101 – Open Soffit Balcony

Overall Balcony

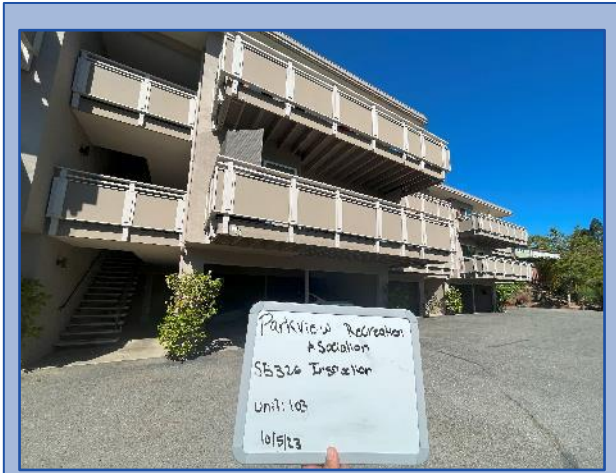
Unit 103 – Open Soffit Balcony

Overall Balcony

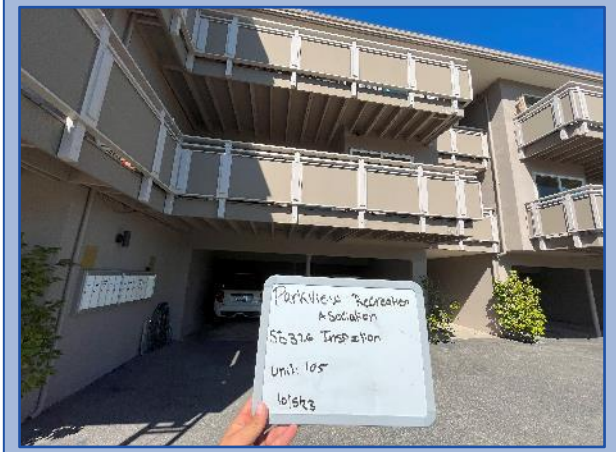
Unit 105 – Open Soffit Balcony

Overall Balcony

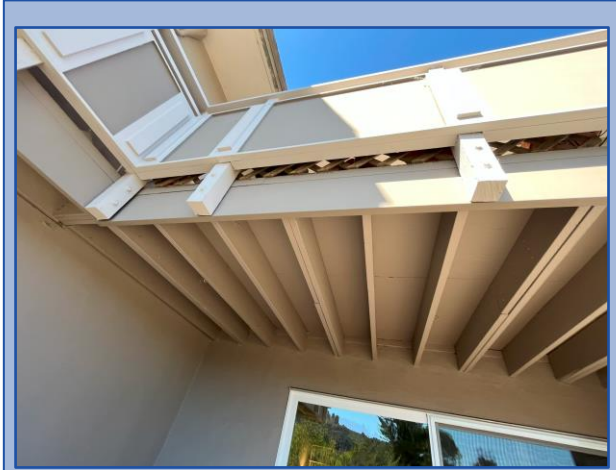
Underside of balcony and framing are in good condition

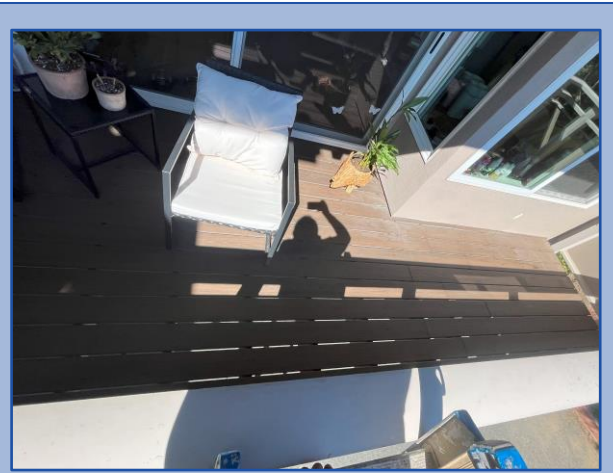
Balcony surface is in good condition

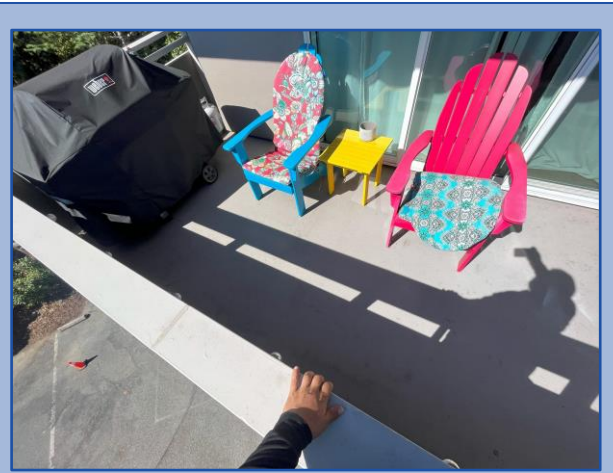
Balcony surface is in good condition

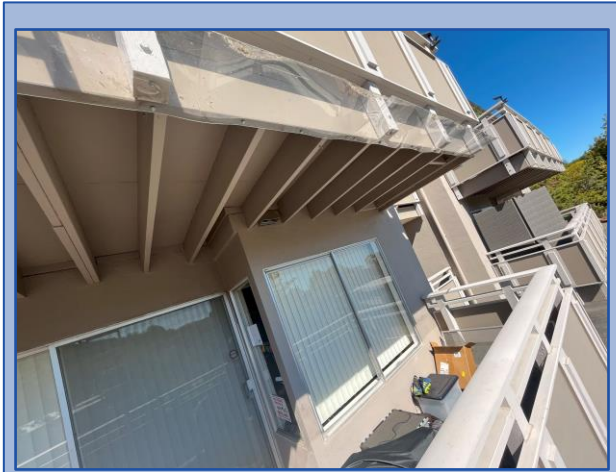
Underside of balcony and framing are in good condition

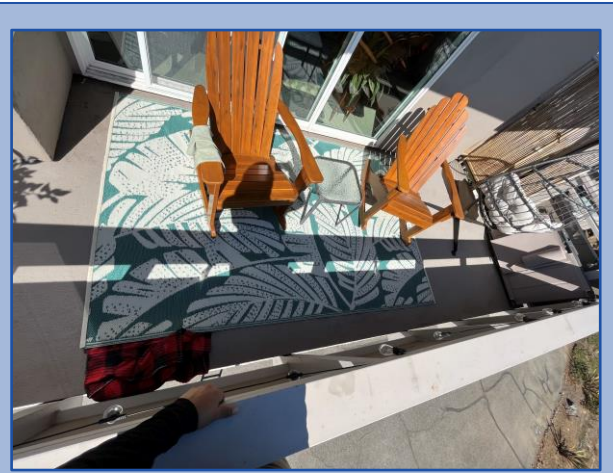
Balcony surface is in good condition

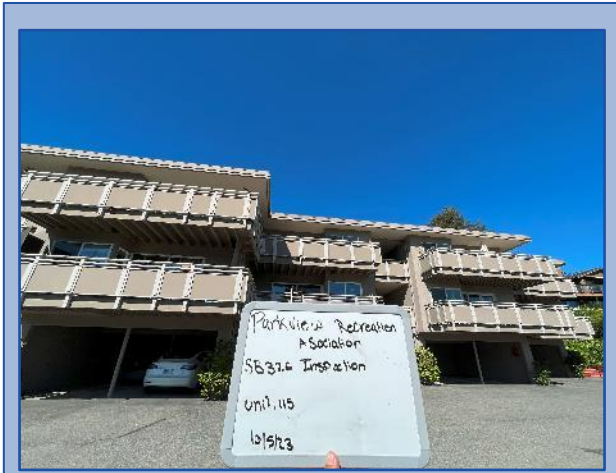
Unit 115 – Open Soffit Balcony

Overall Balcony

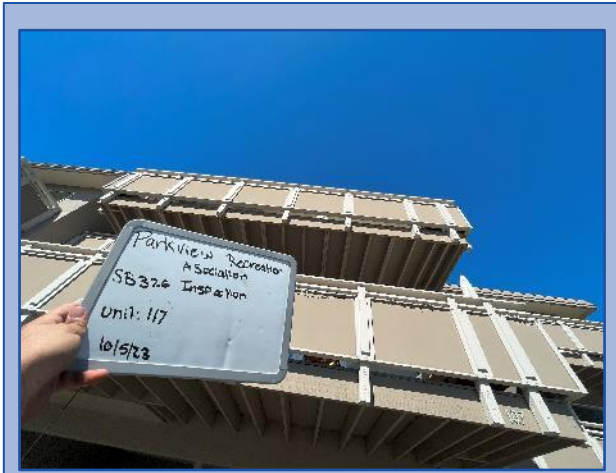
Unit 117 – Open Soffit Balcony

Overall Balcony

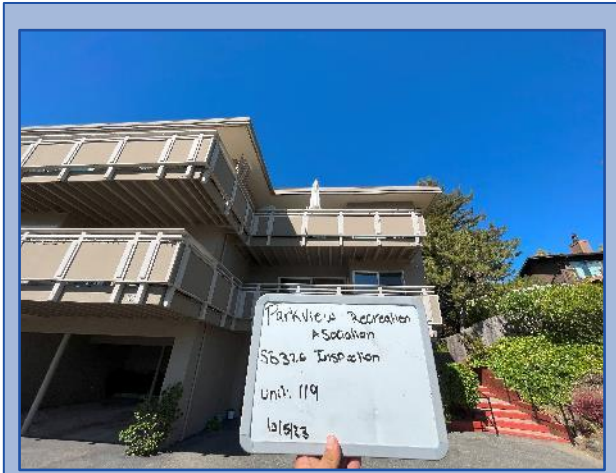
Unit 119 – Open Soffit Balcony

Overall Balcony

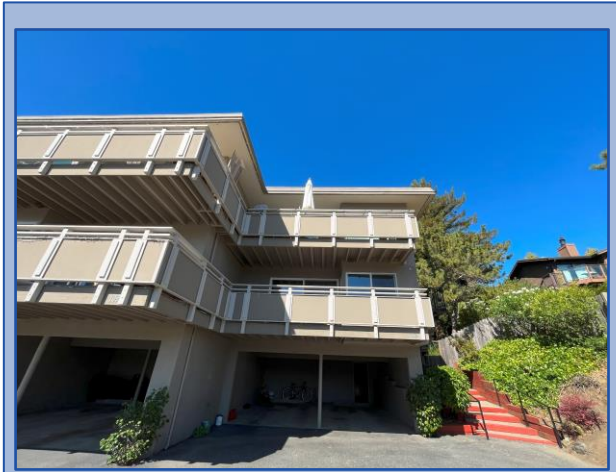
Underside of balcony and framing are in good condition

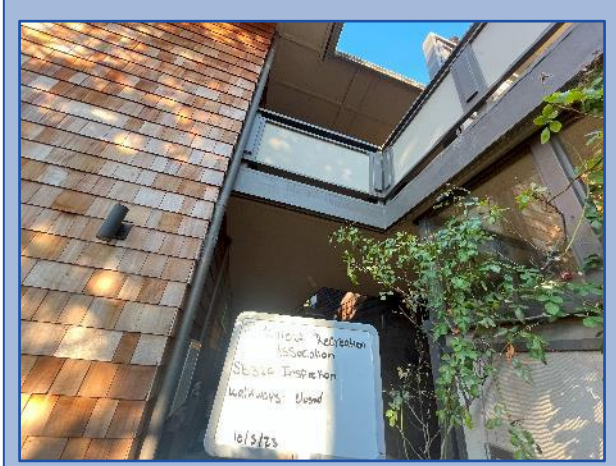
Unit 177/179 Walkway – Closed Soffit

Overall Walkway

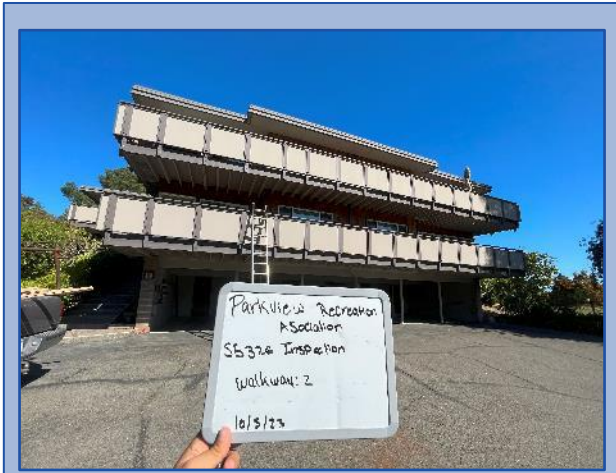
Unit 2 Walkway – Open Soffit

Overall Walkway

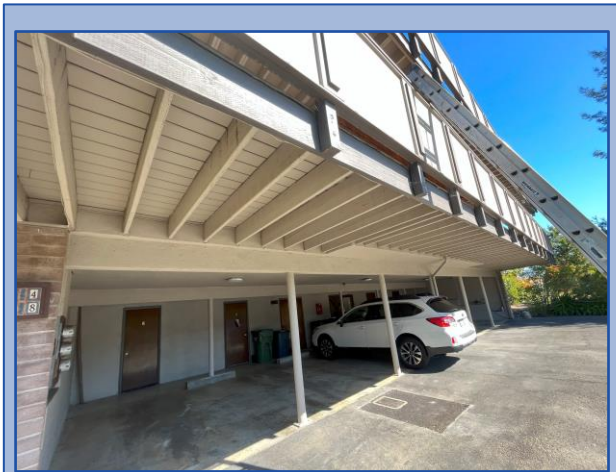
Underside of walkway and framing is in good condition

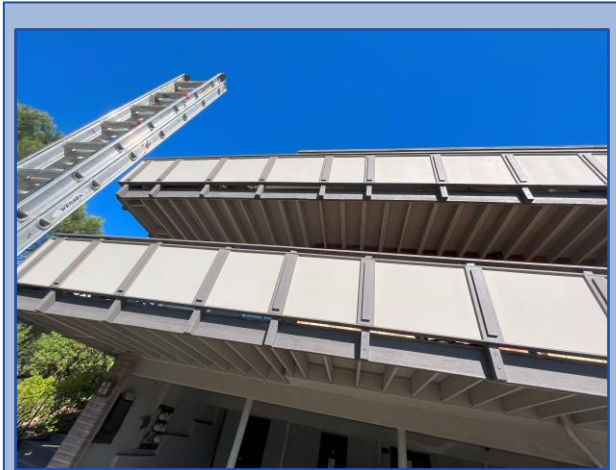
Underside of walkway and framing is in good condition

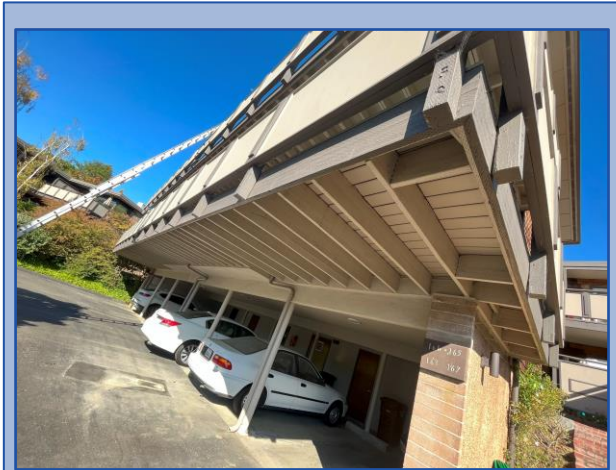
Underside of walkway and framing is in good condition

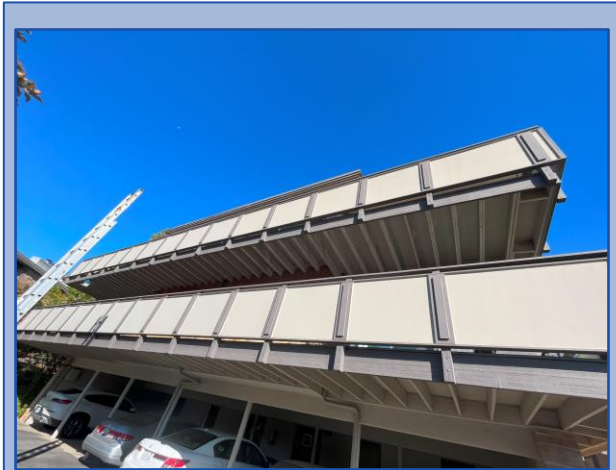
Underside of walkway and framing is in good condition

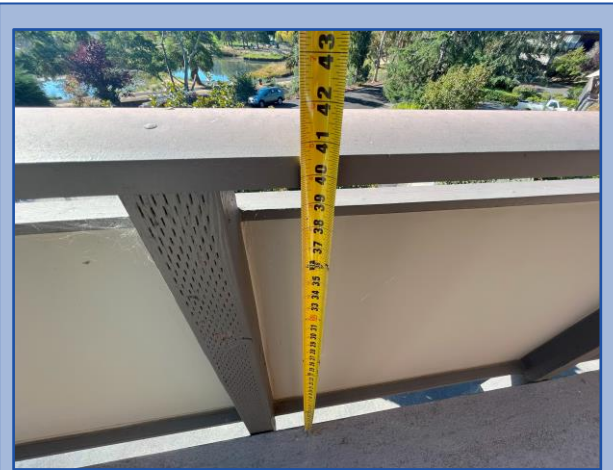
Railing height does not meet current building code requirements

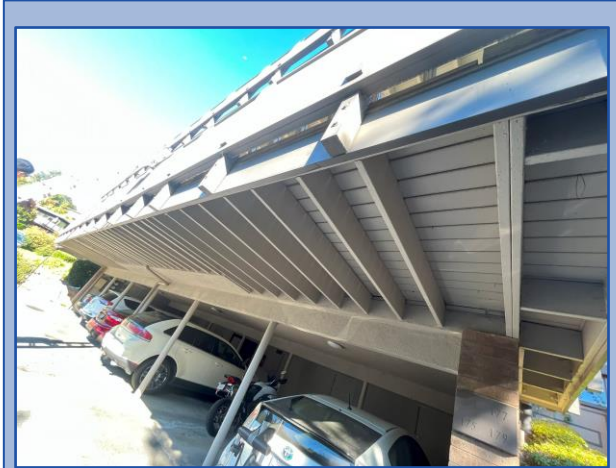
Underside of walkway and framing is in good condition
